Rain World Environmental Consultants

Subject: School Crossings and Roadway Markings

After completing a survey of public, charter and private schools in Maricopa, and important intersections, we have developed findings of significant interest that need to be addressed. To better assist the City of Maricopa, please find a descriptive list of the current school crossings and intersections with photos for placement of proper engineering controls.

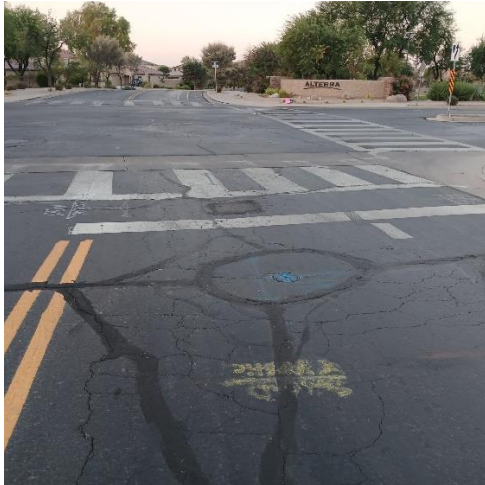
1. Maricopa Elementary School
18150 North Alterra Parkway
Maricopa AZ 85139

North Alterra Pkwy facing south as crosswalk markings are white horizontal and vertical lines. The intersection is controlled by stop signs on the north and south sides only.

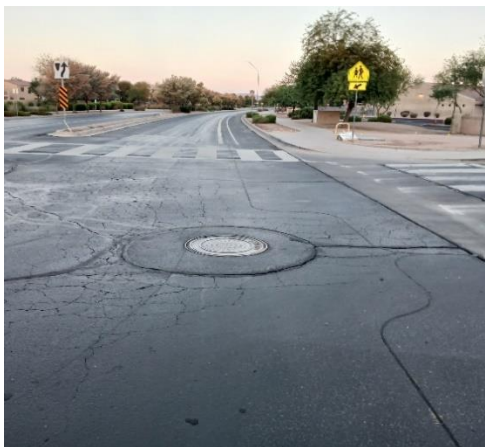
Bolin Road facing west toward the school on the right.

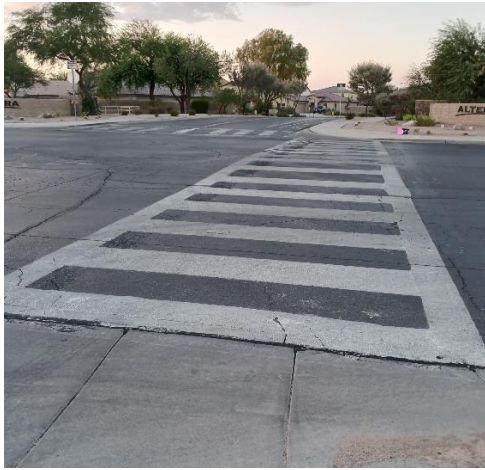
Crosswalk facing south on North Alterra with traffic coming from the right or west. It is here in the top right in photo or SW of the crosswalk that it has been witnessed on several occasions vehicles turning left making U-turns over the crosswalk during school hours. A sign needs placed stating "No U-Turns During School Hours".

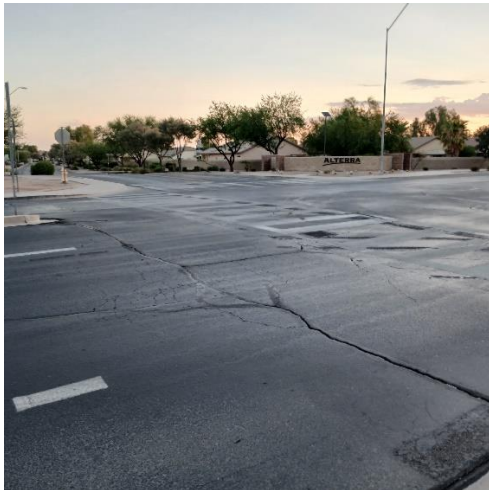
S W side of Bolin Rd intersection facing North. This is the portion where vehicles turn left to make a U-turn during school hours.

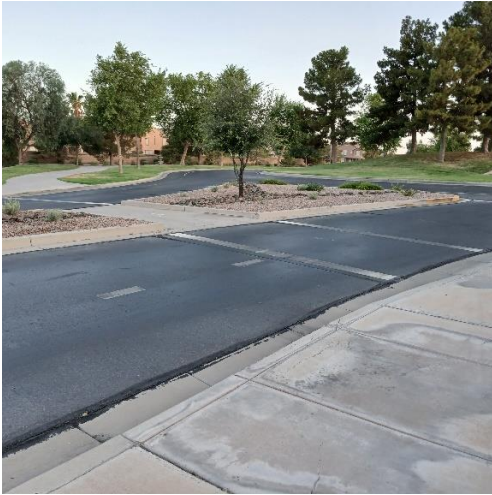
First round about school crosswalk entering north on N. Hogenes Blvd. past school driveway at traffic circle facing N W.

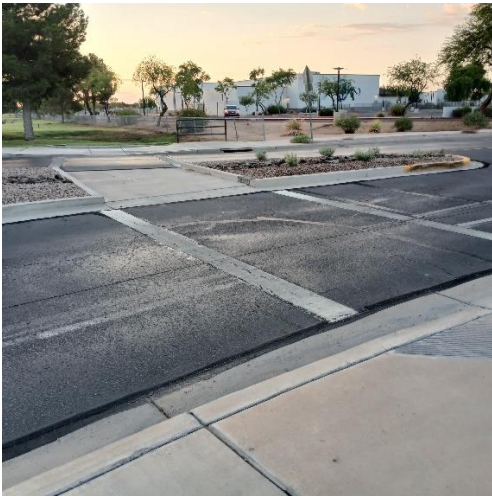
First school roundabout crosswalk exiting South Hogenes Blvd. before school driveway at traffic circle facing S E toward school,

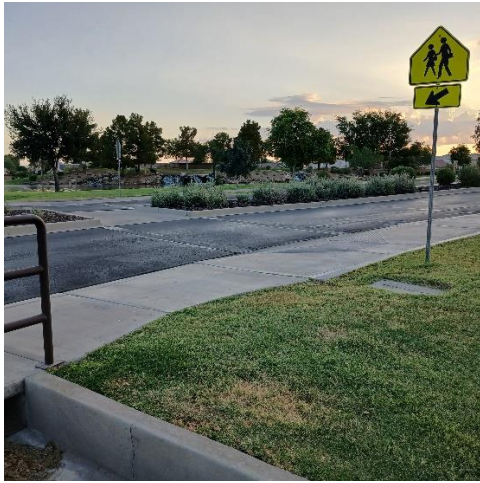
Second School roundabout school crosswalk
Exiting traffic circle on West Honeycutt

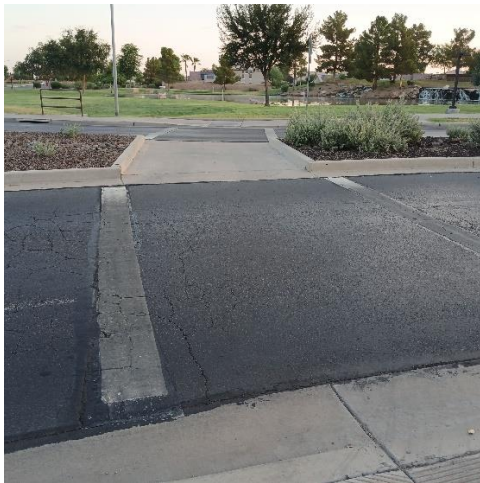
Viewing E and W lanes of round about
crosswalk facing north with median on West
Honeycutt. The bushes left in median need
trimmed so not to block legs of pedestrians

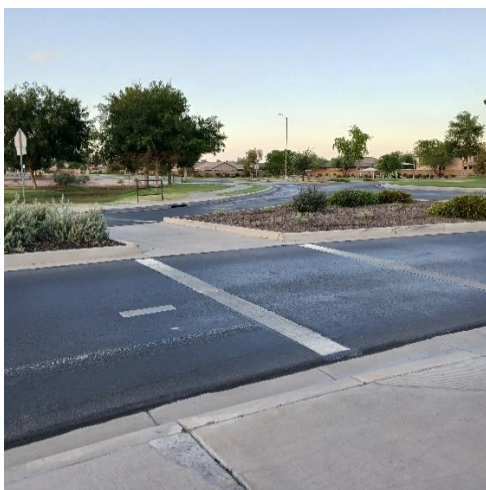
Viewing W and E lanes of round about
crosswalk facing south with median on West
Honeycutt.

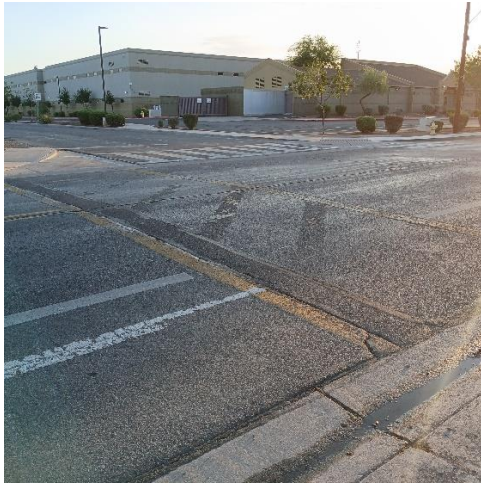
Old crosswalk at S W corner of Taft Avenue and W. Honeycutt facing north. These yellow markings need to be ground off as it distracts and confuses drivers of true markings of intersection and does not properly inform drivers of traffic control.

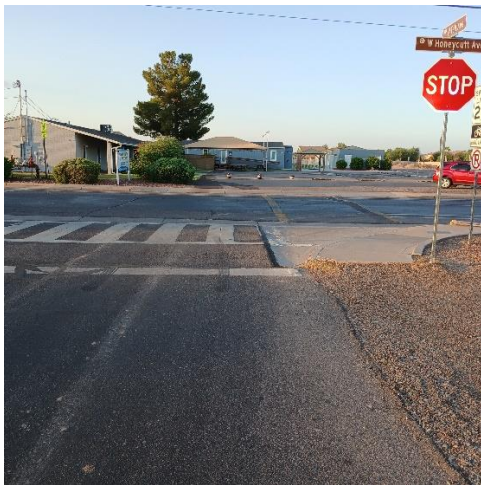
N W corner of S Taft Avenue and W. Honeycutt facing south. Depicts the old yellow crosswalk on Honeycutt and the white horizontal and vertical crosswalk at stop sign at Taft.

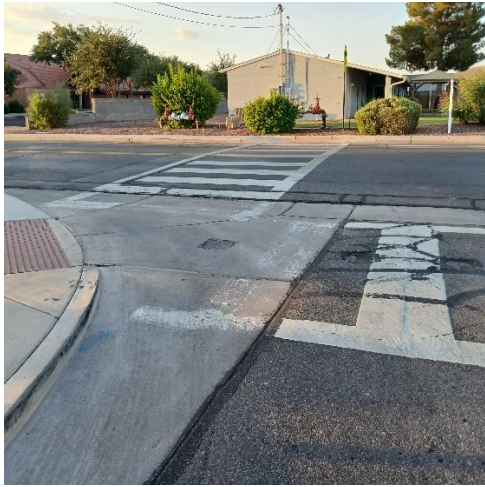
N E corner of Taft Avenue and W. Honeycutt facing south depicting incorrect and degraded markings.

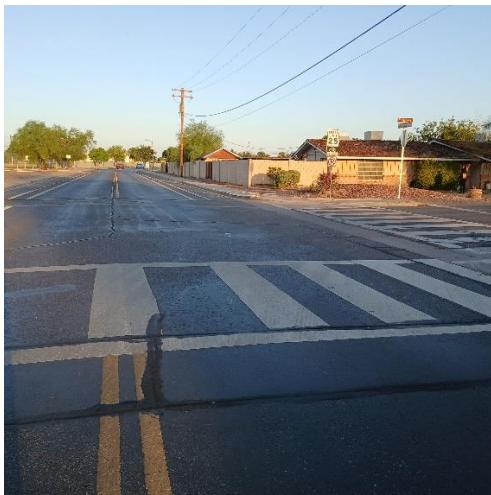
East side of crosswalk at centerline of W. Honeycutt depicting all three crosswalks facing west.

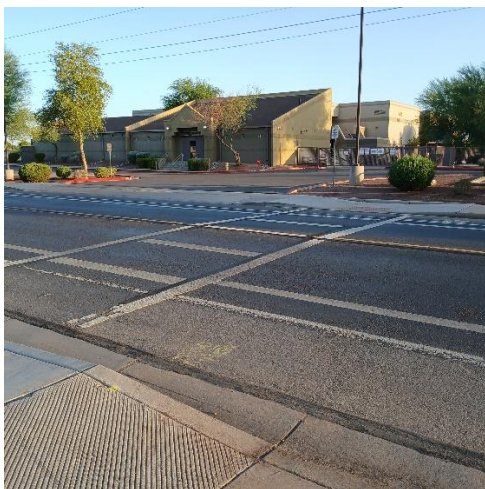
Second school crosswalk on W. Honeycutt facing N W towards school with incorrect markings.

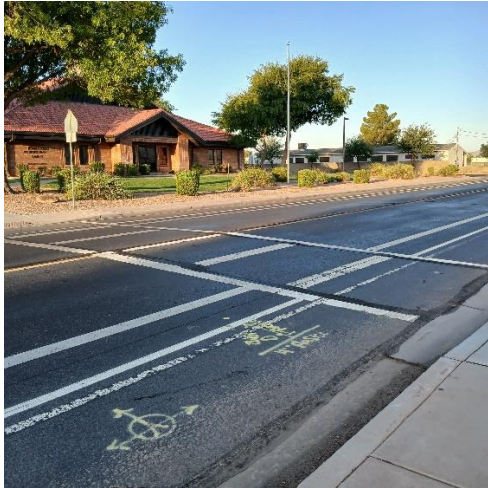
Second school crosswalk on W. Honeycutt
facing S W towards church.

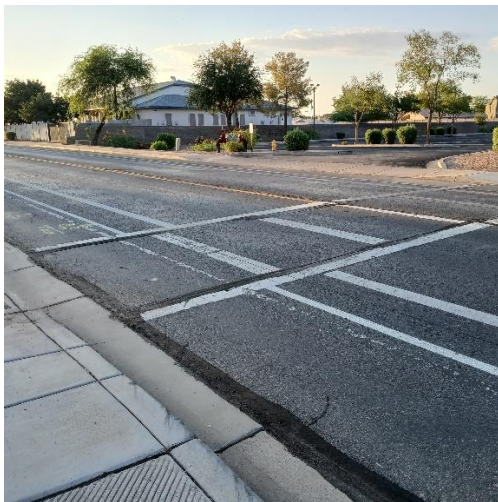
Second school crosswalk on W. Honeycutt
facing S E towards church parking lot.

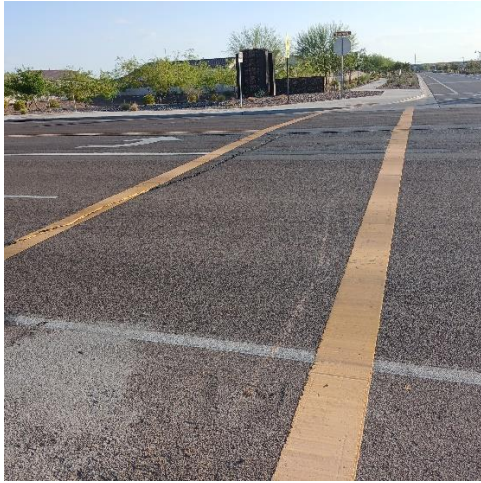
School crosswalk on SW Honeycutt Rd and E. Costa Del Sol Blvd. facing N E within 600 feet of school driveway. Incorrect markings for school crosswalk.

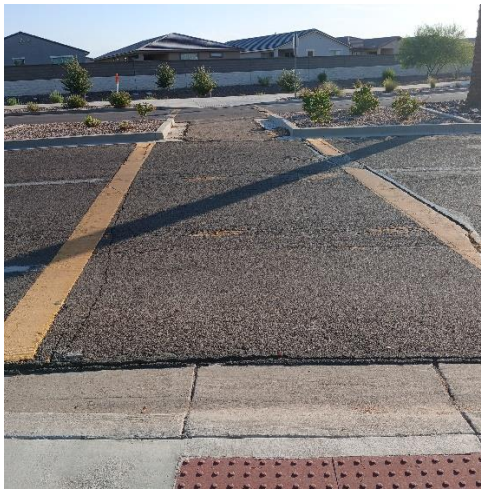
Crosswalk on SW Honeycutt facing N E just before entering roundabout, incorrect markings and degraded median needing repair.

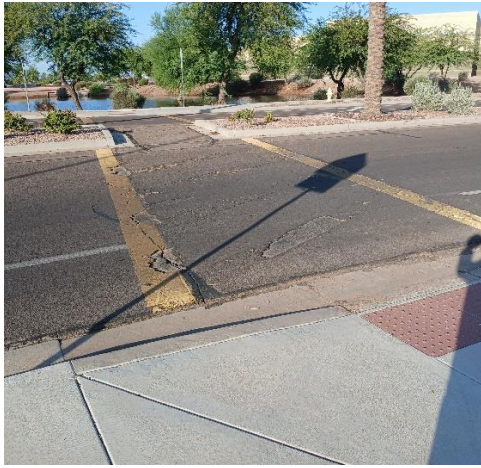
Degraded crosswalk exiting S W round about. Incorrect markings and not ADA compliant.

NOTE: The crosswalk opposite the S W roundabout on Honeycutt past S. Tarragona Blvd. is also incorrectly marked. The one on Tarragona is correct but in disrepair.

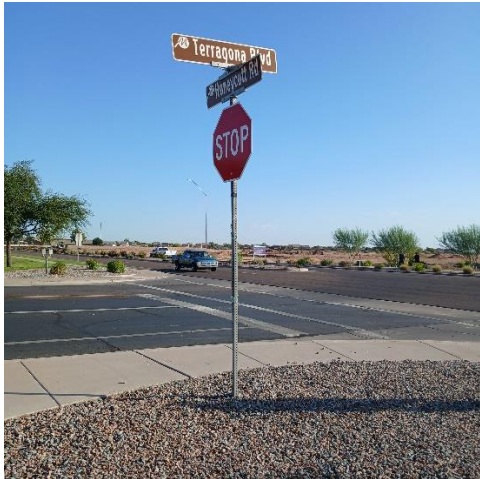
S W corner of Honeycutt and north end of Tarragona Blvd. T intersection. Before school. Incorrect school zone markings

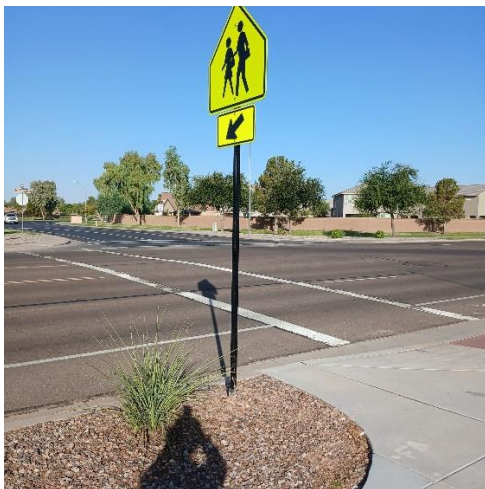
N W side of Honeycutt facing north end of Tarragona at T intersection. Incorrect markings.

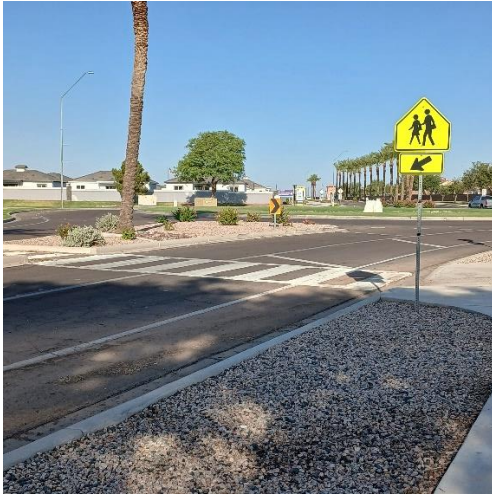
Crossing at the roundabout on Honeycutt and North Casa Del Sol Blvd facing S W. Incorrect markings.

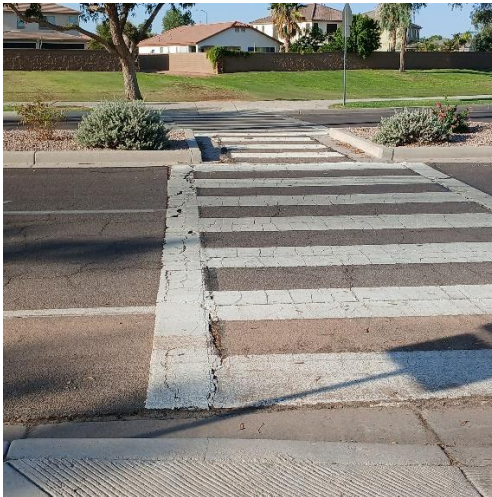
Crossing at the roundabout on Honeycutt and North Casa Del Sol Blvd facing S W. Crosswalk is incorrect markings and degraded, not ADA compliant.

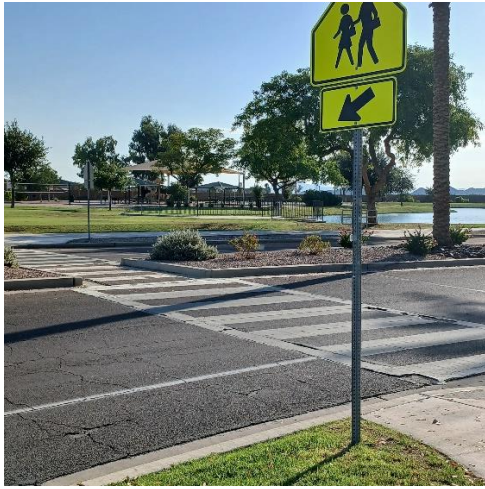
Crossing at the roundabout on Honeycutt and North Casa Del Sol Blvd facing S W. Crosswalk is incorrect markings and degraded, not ADA compliant.

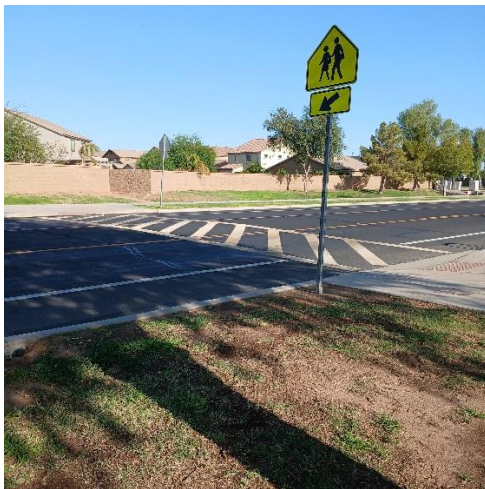
Crosswalk on North Casa Del Sol Blvd facing S W and north of the school. The crosswalk is marked correctly but is degrading.

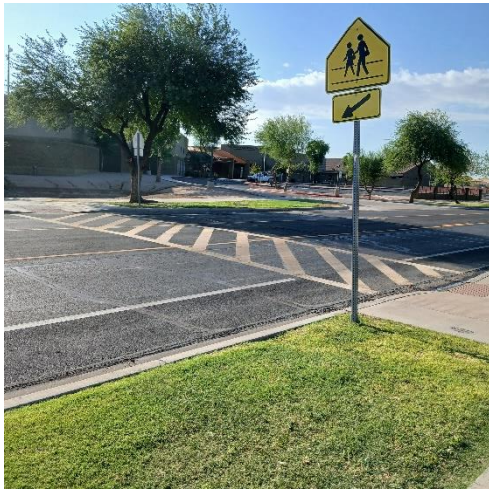
Crosswalk on North Casa Del Sol Blvd facing S E towards the school. The crosswalk is marked correctly but is degrading.

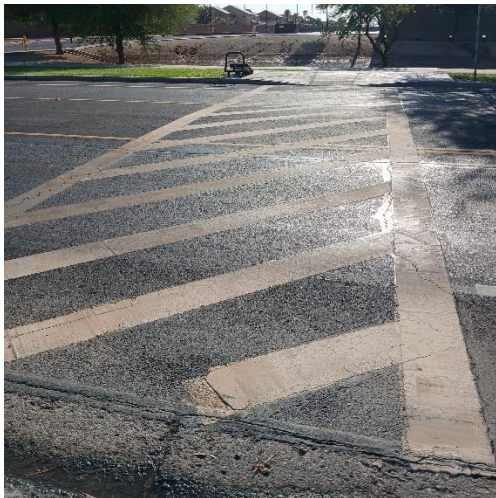
Crosswalk on North Casa Del Sol Blvd facing E. The crosswalk is marked correctly but is degrading.

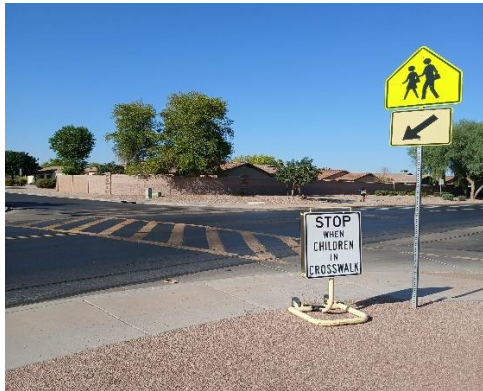
Cross section of 3-way intersection that turns into school bus lane on the right in photo being on north side of W. Rancho El Dorado Pkwy. Photo taken facing S W.

NOTE: This crosswalk is located at the incorrect place. It is to the east of the school bus driveway and should be on the other side of the bus driveway. This is due to crosswalks needing to be closest to a school at an intersection. There is no crosswalk from this location crossing the bus driveway which is a safety hazard. It should be located to the west of the bus driveway.

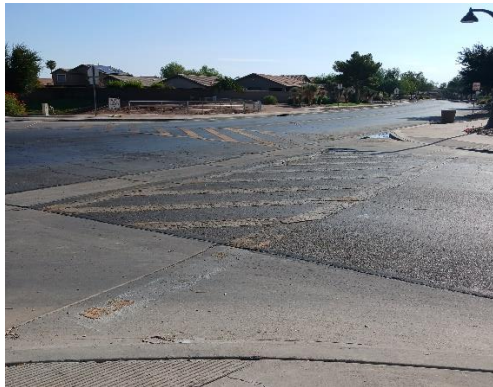
Degraded crosswalk on south side of W. Rancho El Dorado Pkwy and Bishop Dr. facing N E.

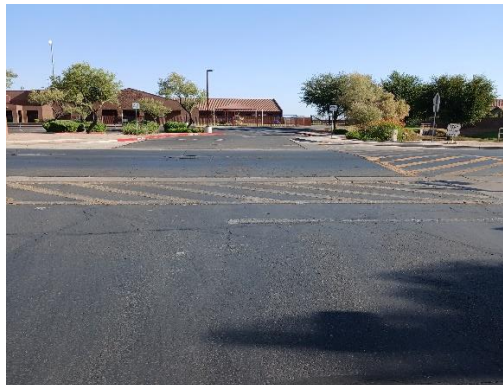
View of degraded crosswalks from N. Bishop Dr. facing bus driveway.

NOTE: This depicts the location of crosswalk on east side of W. Rancho El Dorado Pkwy. Crossing here would require students to cross the bus driveway when it is not marked endangering them.

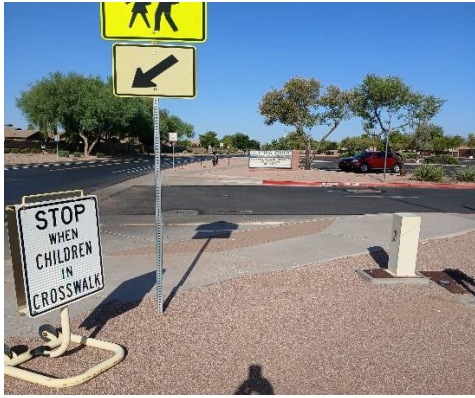
Picture of bus driveway on N side of W. Rancho El Dorado Pkwy facing west.

NOTE: The bus driveway does not have a crosswalk for students to traverse across safely. Even when a new crosswalk is in place on the west side of the driveway, a connecting sidewalk should be in place here over the driveway.

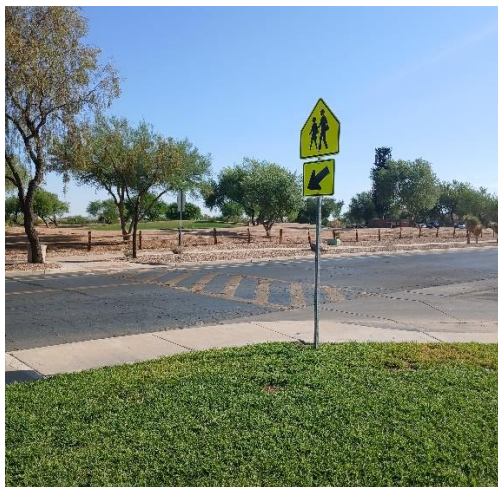
Picture of T intersection North Santa Rosa Drive at W. Rancho El Dorado Pkwy facing N E towards golf course. Crosswalk is degrading.

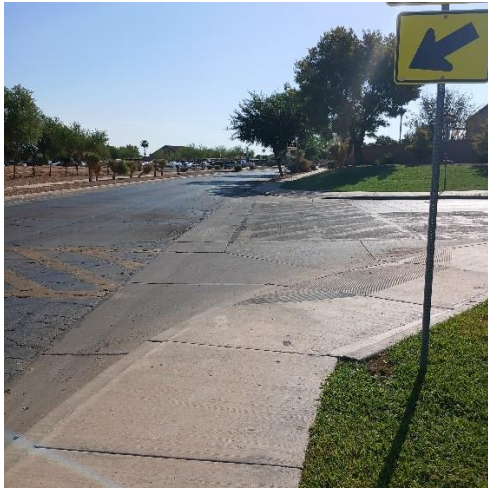
Crosswalk at T intersection of North Santa Rosa Drive at W. Rancho El Dorado Pky facing East. Depicts both crosswalks in degraded condition and not ADA compliant.

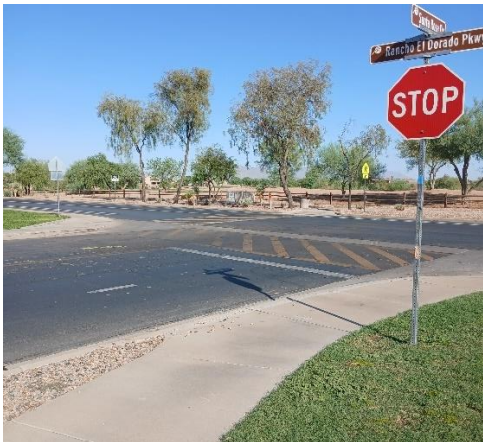
Crosswalk at North Santa Rosa Drive at W. Rancho El Dorado Pky facing N W towards golf course. This depicts degraded crosswalk and incorrect placement as they are not extended to the curb on both crosswalks and not ADA compliant.

NOTE: There is not a crosswalk sign at the N W corner of this intersection of North Santa Rosa Drive at W. Rancho El Dorado Pky facing North at the T.

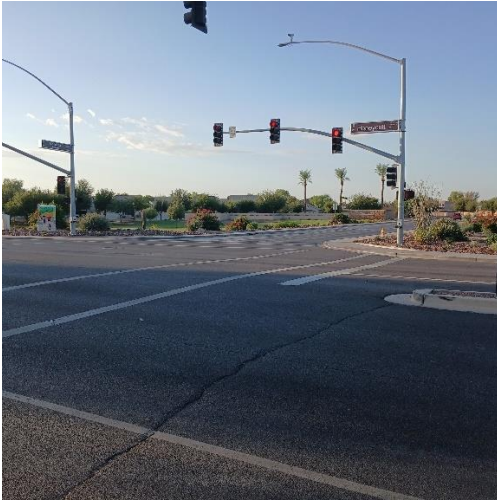
Four ways stop intersection where all the school crosswalks are incorrectly marked. This picture is at N W corner of Honeycutt and North Donithan Rd. facing S E.

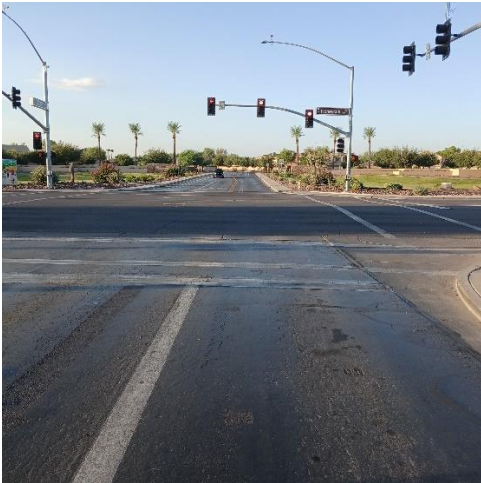
Incorrectly marked school crosswalk on North Donithan Rd. and W Honeycutt facing south.

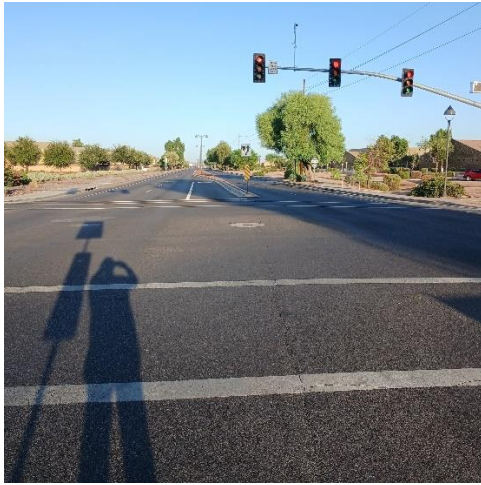
Incorrectly marked school crosswalk on W. Honeycutt and North Donithan Rd. facing west.

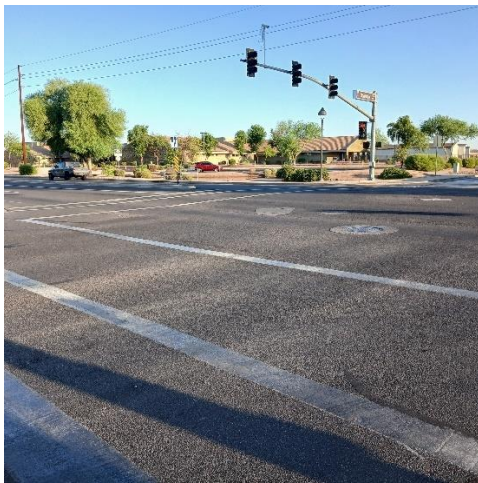
Incorrectly marked school crosswalk on W. Honeycutt and North Donithan Rd. at S E corner facing N W.

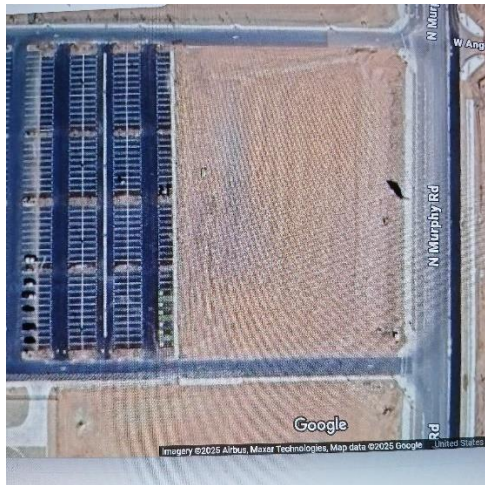
This school does not currently have any crosswalks to the north or south entry/driveways on N. Murphy Road or crossing from N. Angelo Dr. as this cross intersection to the main driveway is still under construction.

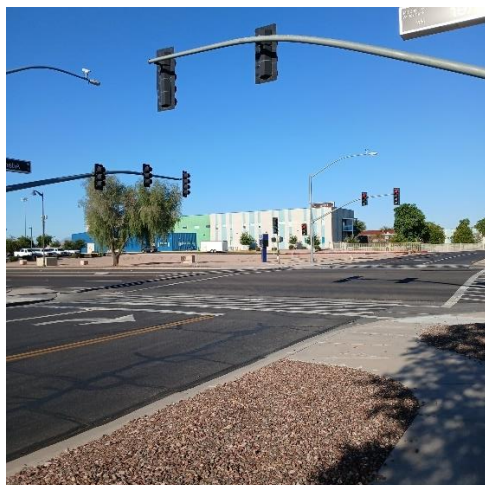
Four-way stop intersection at the S E corner of Porter Rd and Adams facing N W towards Leading Edge Academy. Incorrect crosswalk markings.

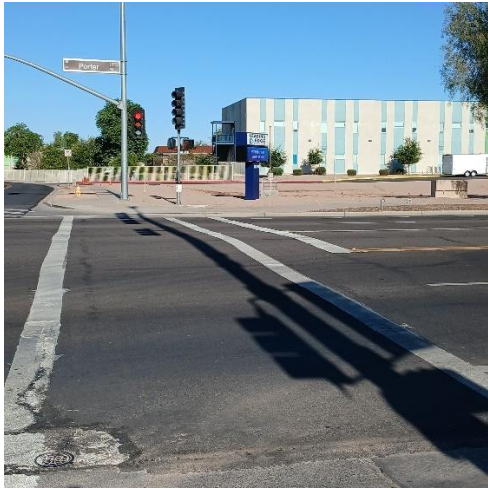
N E corner of Porter Rd at Adams facing west towards Leading Edge Academy. School crosswalk is incorrectly marked at a four-way controlled intersection.

NOTE: School crosswalk is incorrectly marked at a four-way controlled intersection. This should be horizontal lines with diagonal center lines in yellow, as it is the closest crosswalk to the school and to protect pedestrians.

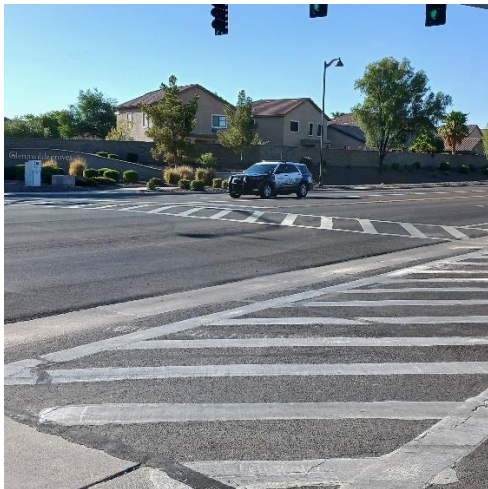
N W corner of Porter Road and Adams facing S E depicting incorrect School crosswalk markings.

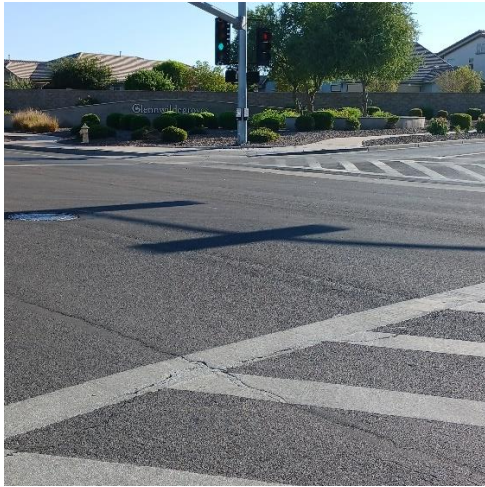
S W corner of Porter Rd and Adams facing N E depicting incorrect school crosswalk markings across center of intersection.

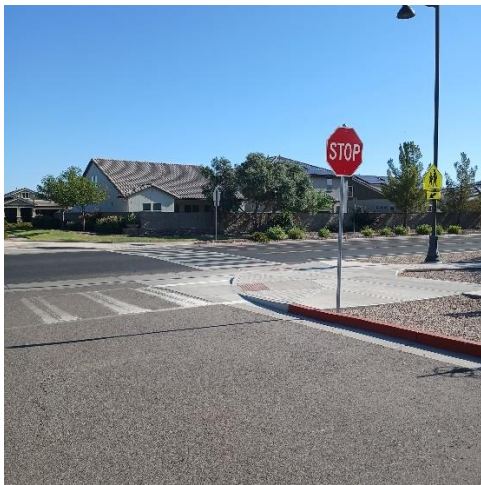
Two way stop intersection at school driveway S E corner at W. Allen Stephens Pkwy facing north on N. Falcon Ln. There is not a School Crossing sing and no stop line before

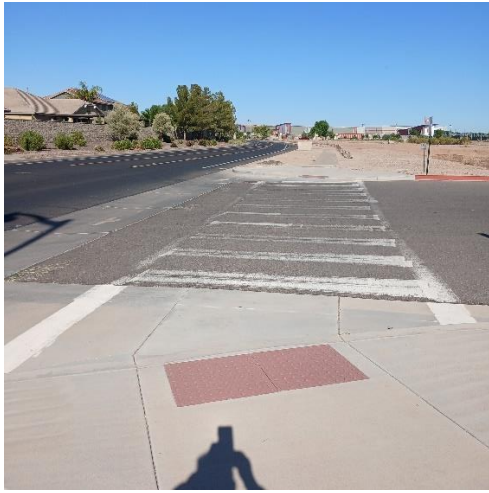
Crosswalk at S W corner of school driveway and W. Allen Stephens Pkwy facing east. Crosswalk is incorrect color, no school crossing sign, and no stop line.

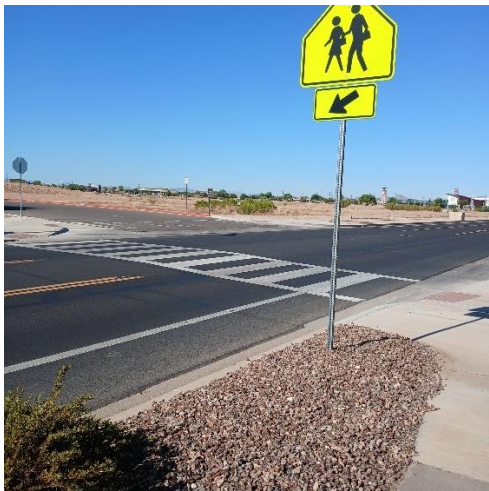
N E corner of W Allen Stephens Pkwy and N. Falcon Ln. Crosswalk is incorrect color.

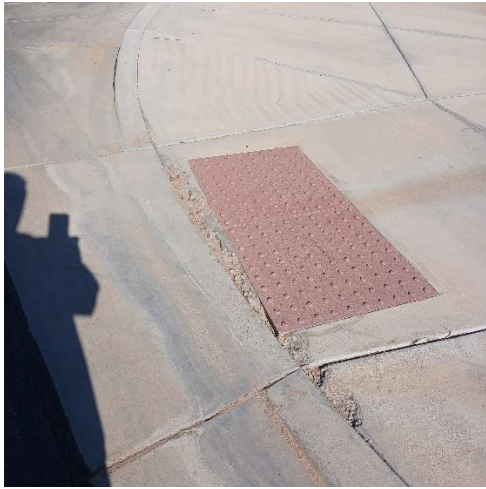
N E corner of W Allen Stephens Pkwy and N. Falcon Ln. Concrete around the south edge of ADA transition pad is degraded, not ADA compliant.

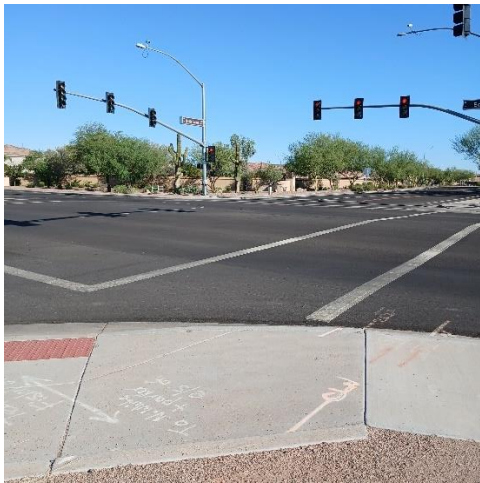
Fourways stop intersection with four crosswalks withing 600 feet of the school. S E intersection of W. Bollin Rd and Smith Farms Circle.

NOTE: All for of the crosswalks are within 600 feet of the school and do not have school crossing signs and are not high visible yellow crosswalks.

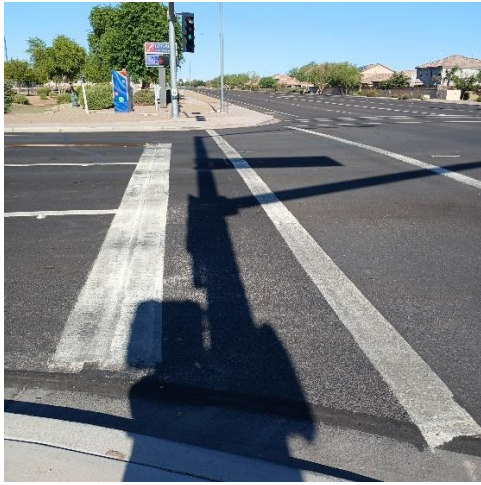
S E intersection of W. Bollin Rd and Smith Farms Circle facing west towards the school. This is an exit for both the school and the community college.

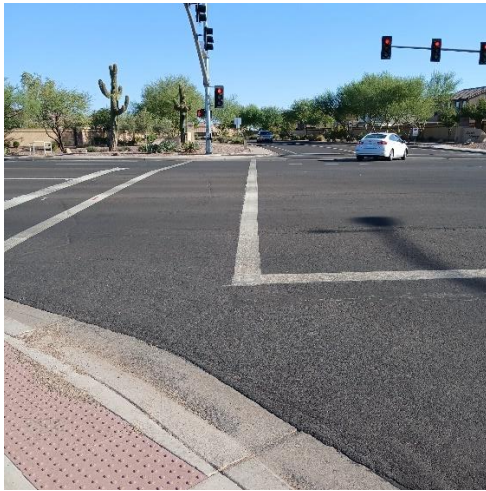
S W corner of W. Bollin Rd and Smith Farms Circle facing north. Descriptive of incorrect crosswalk markings, high visible yellow would cover curb to curb.

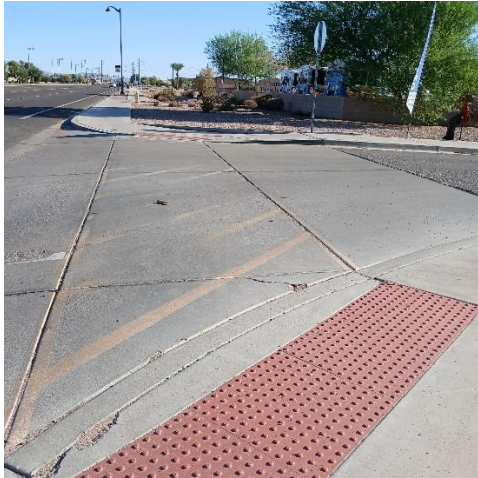
This location shares a main driveway with a day school. Picture is at S E corner of N. Porter Rd. and the active driveway facing north. There are not crosswalk signs and the crosswalk needs redone to be visible.

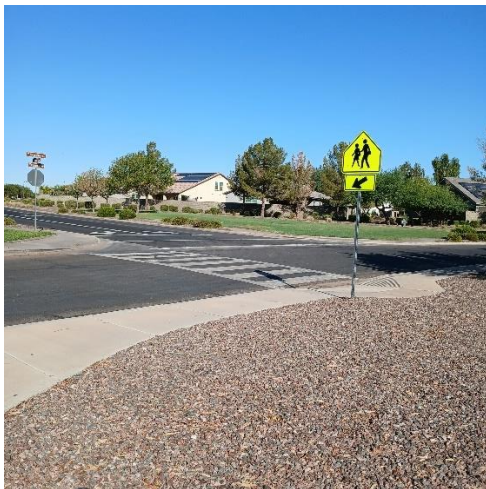
This is a one way stop at a T intersection at Heros Way/ Conner Dr and W. Adams Way. At the S E corner facing N W. Incorrect crosswalk markings.

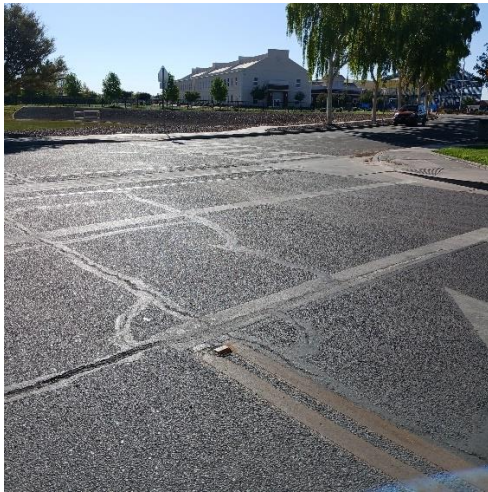
N W portion of T intersection facing S E towards Hover Way. Incorrect crosswalk and color if to work in connection with the other crosswalk and a crosswalk sign.

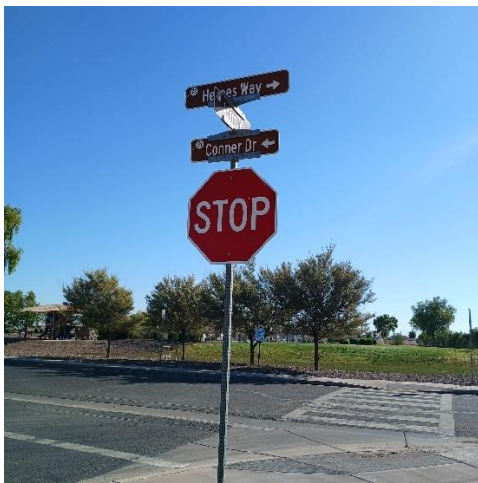
The only control device at this T intersection on S W corner facing east. The crosswalk running N and South is connect to the school crosswalk to the east but is not marked as a school crosswalk or have signage. Not safe for student crossing to this school and St. Michaels.

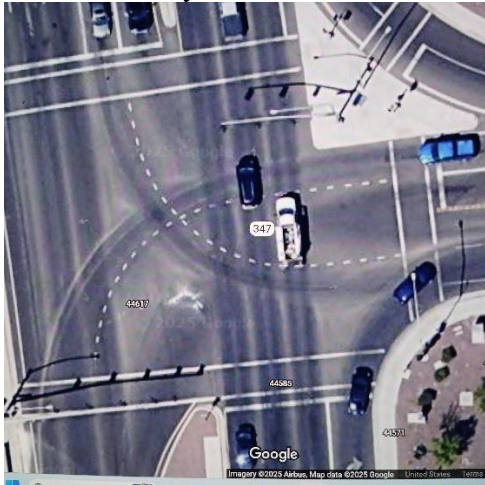
347 and Honeycutt

West bound Honeycutt in on the right. The two turn lanes from Honeycutt to the 347 South has only one dashed line as does the two lanes south on 347 to E Honeycutt. A yellow horizontal center turn lane maker can be added to each for driver clarity in all lighting and weather conditions.

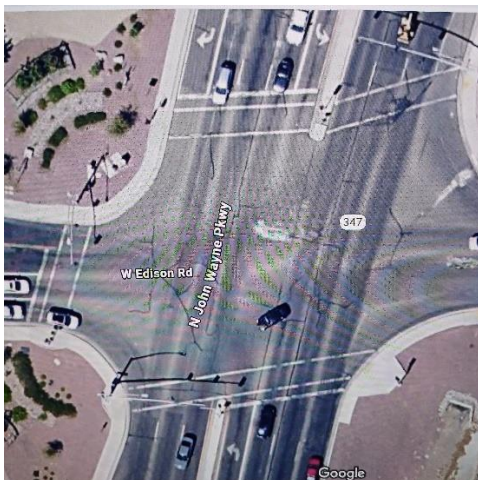
347 and Edison Road

The crown of intersection slopes to the right and left or E and W. Both turn lanes from Edison to 347 have poor visibility. White dashed turn lanes to the left need marked with solid yellow horizontal center lanes.

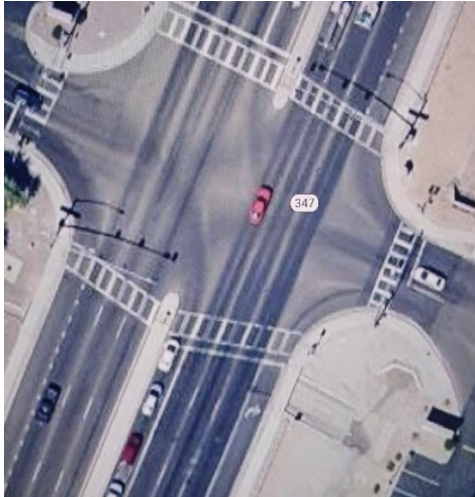
347 & Marketplace

Marketplace runs E and W or left to right. Intersection is crowned with diminished visibility in light and night hours, and in climate weather. The right run lane onto the 347 and left lane onto the 347 should have both white dashed lines and a solid yellow center line to better define intersection.

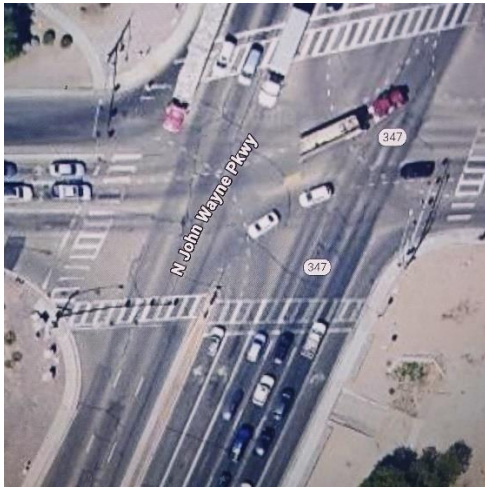
347 and W. Smith Enke Rd.

This intersection was reconstructed this past year. The right turn lane from W bound Smith on the right, was corrected. The remaining left turn lanes have two lanes for turns. Those lanes should have the horizontal dashed white line with solid yellow center line.

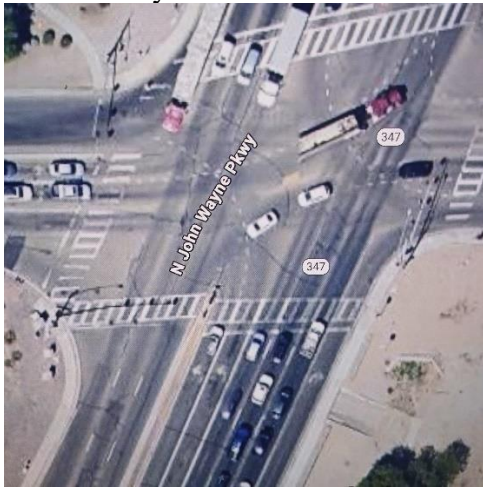
N. John Wayne and Cobblestone Farms Road

This intersection was recently reconstructed. The top left indicates the south bound lanes on N. John Wayne. These as well as the others turning left and right should have white horizontal dashed turn lanes and solid yellow horizontal center line turn lane.
